**US Army Corps
of Engineers**

USACERL Technical Report 96/77
July 1996

Investigation of Preapproved Underground Heat Distribution Systems

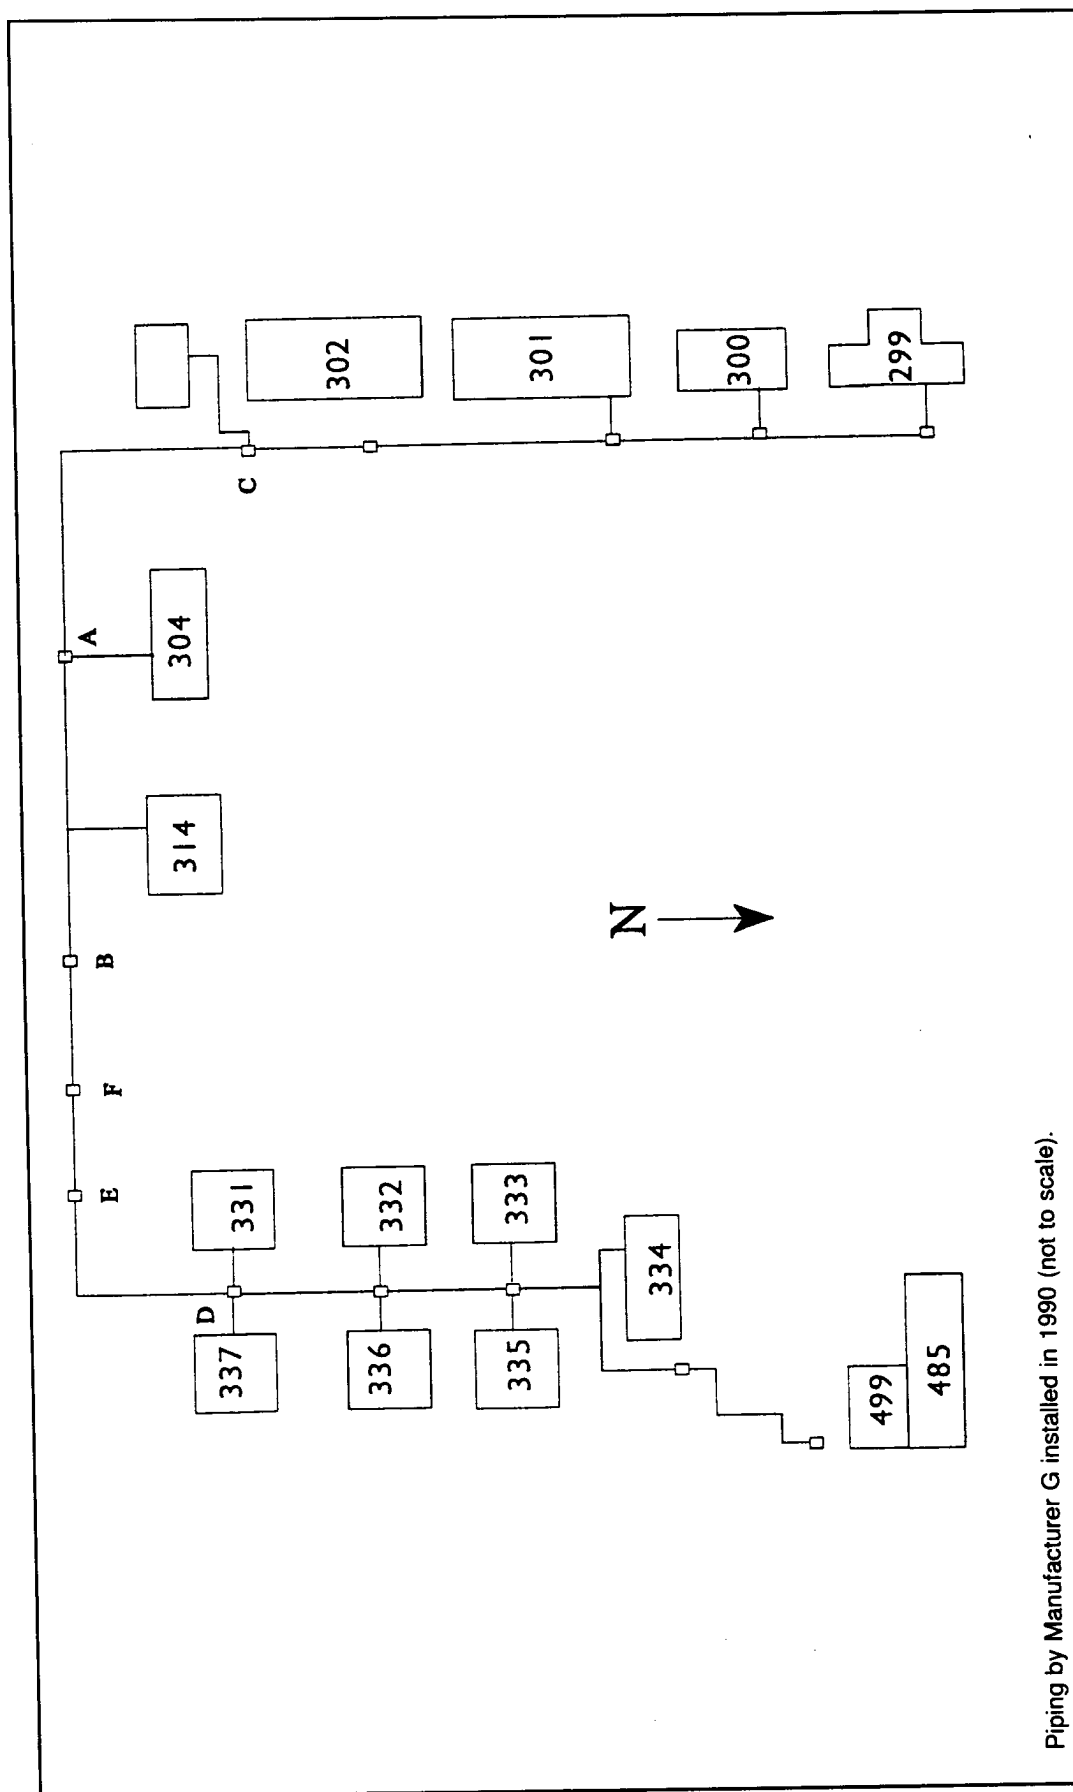
Figure P1. Schematic diagram of System 34 at San Diego Naval Training Center, CA.

a. Pressure tests - Manhole A to Bldg. 304—The supply and return conduits extended 30 ft from Manhole A to risers just outside of Bldg. 304. Manhole A was directly south of the building and had a raised, fabricated metallic top extending about 18-in. above grade. The top had louvered side panels for ventilation. The manhole was concrete with dimensions of 12 ft x 7 ft x 8 ft deep and was served by a steam jet sump pump located in a corner pit. Conduit wall penetrations were caulked and cemented. The steam line had a small flange gasket leak. Gland seals were installed on the piping both in the manhole and at the building risers. All gland seal nuts were loose and had to be tightened before pressure testing. The steam conduit casing was 9 in. in diameter and contained a 3-in. pipe. The condensate conduit casing was 6 in. in diameter with a 2-in. return line.

10:00 AM — 15.0 psi
 10:05 AM — 7.5 psi
 (Leak at vent - Repressurized)
 10:23 AM — 15.0 psi
 10:28 AM — 12.0 psi
 10:33 AM — 9.5 psi
 10:38 AM — 7.7 psi
 10:43 AM — 6.2 psi
 10:53 AM — 3.7 psi

Steam Conduit: The casing would not hold pressure above 5 psi. Gland seals were inspected to ensure that there were no leaks. Pressure dropped rapidly to zero when the compressor was valved off.

Condensate Conduit: The casing would not hold pressure above 7 psi. A very slight air leak was noted at the Manhole A gland seal, which could not be tightened. Pressure dropped rapidly to zero when the compressor was valved off.
